Noank Elementary School Building and Site Analysis

**Prepared by
Town of Groton
Public Works Department**

July 2010

Building Condition
As of June 1, 2010

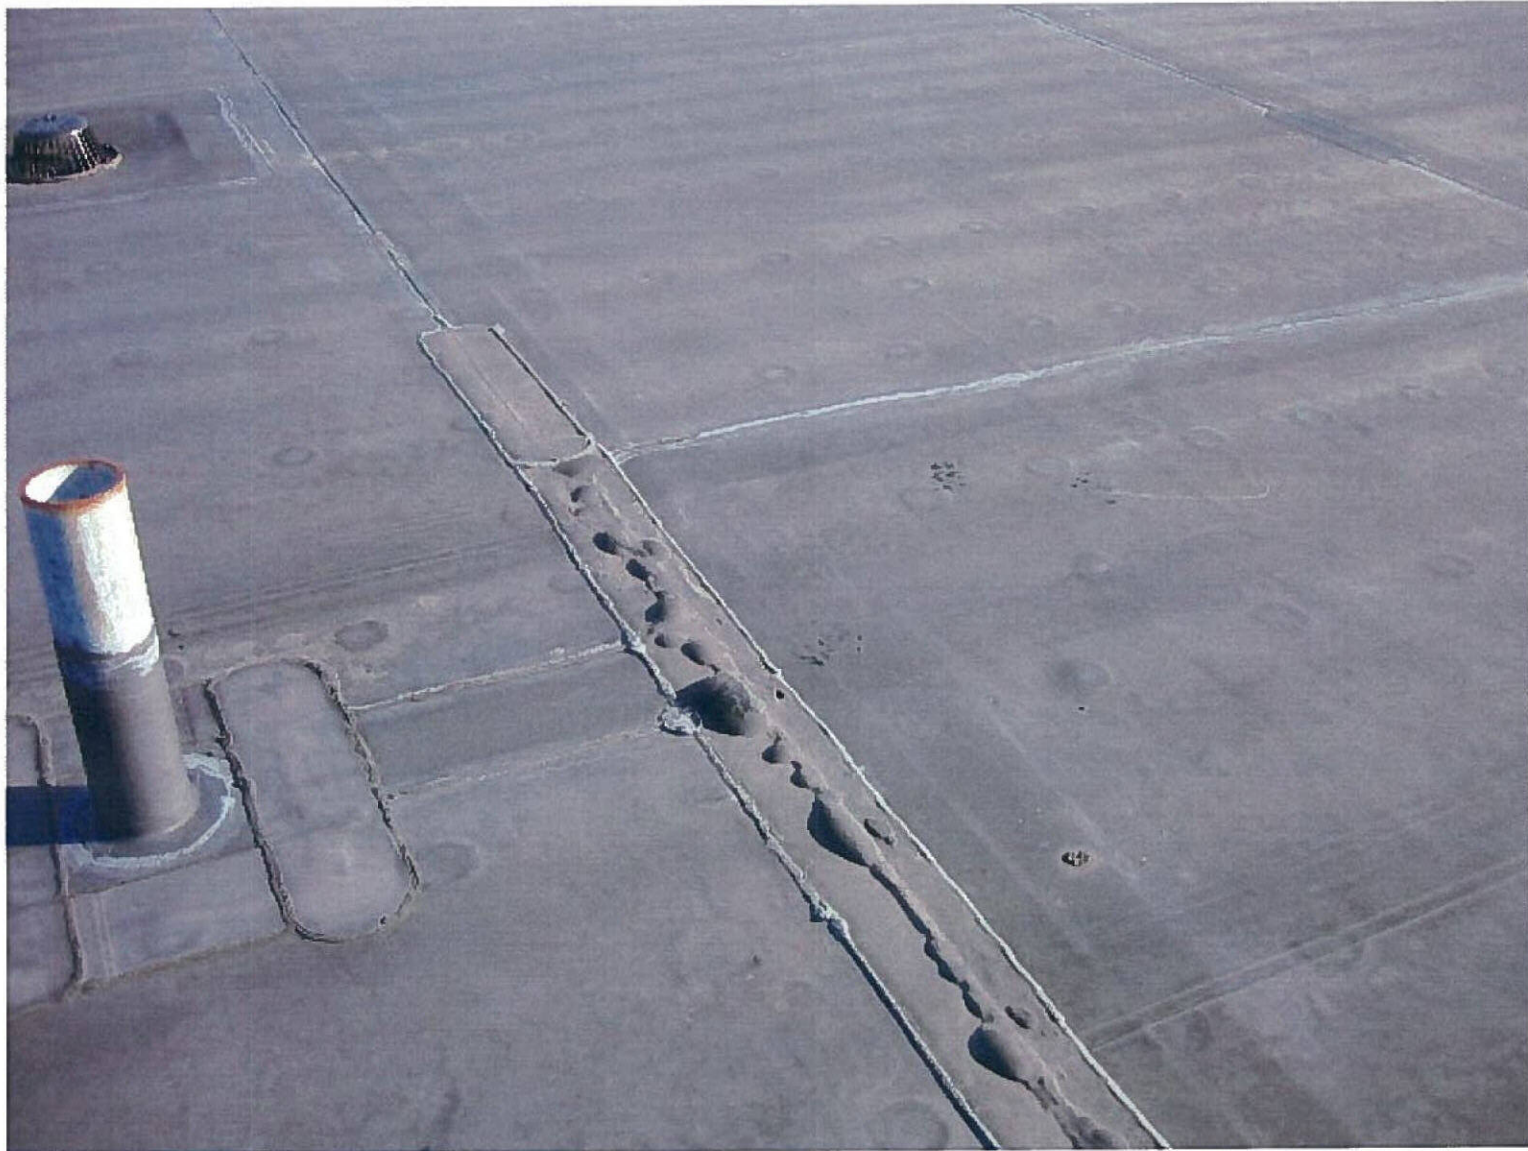
Numerous roof patches that continue to fail

Using a calculator at <http://www.coolflatroof.com/roofing-price-calculator.php>, the cost to replace could range from a very low of \$400,000 which represents ideal conditions and replacement of the membrane to \$1.6 million for more difficult structural repairs.

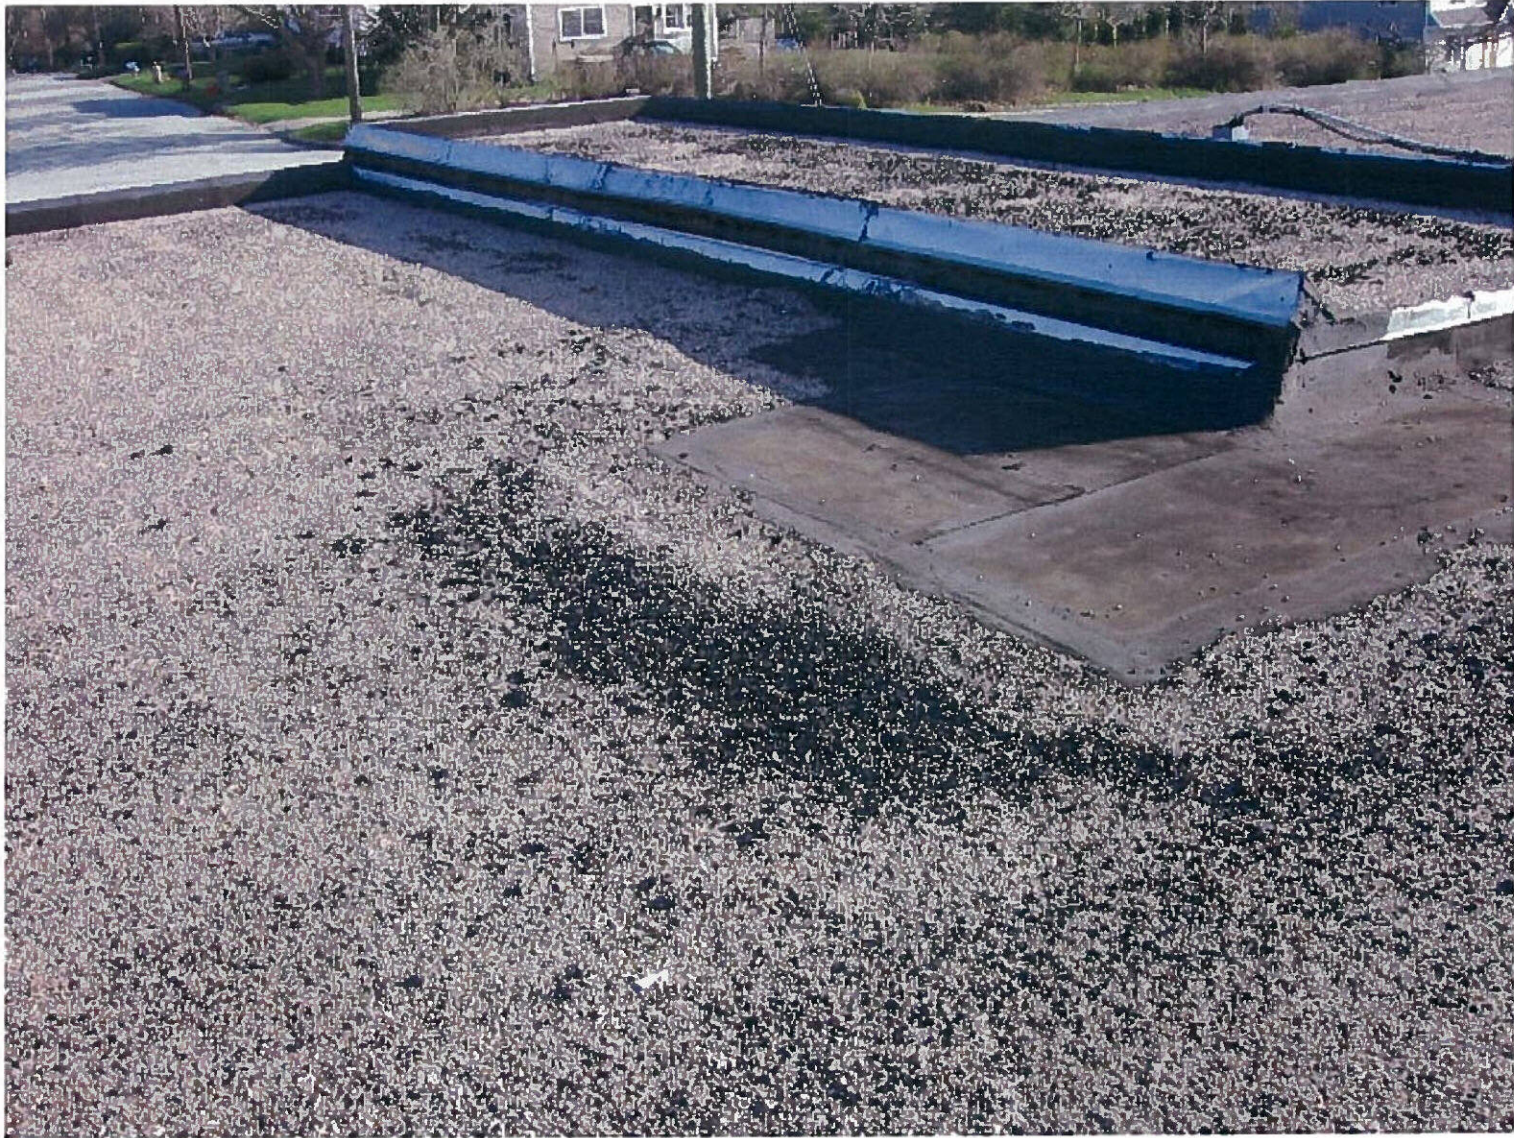
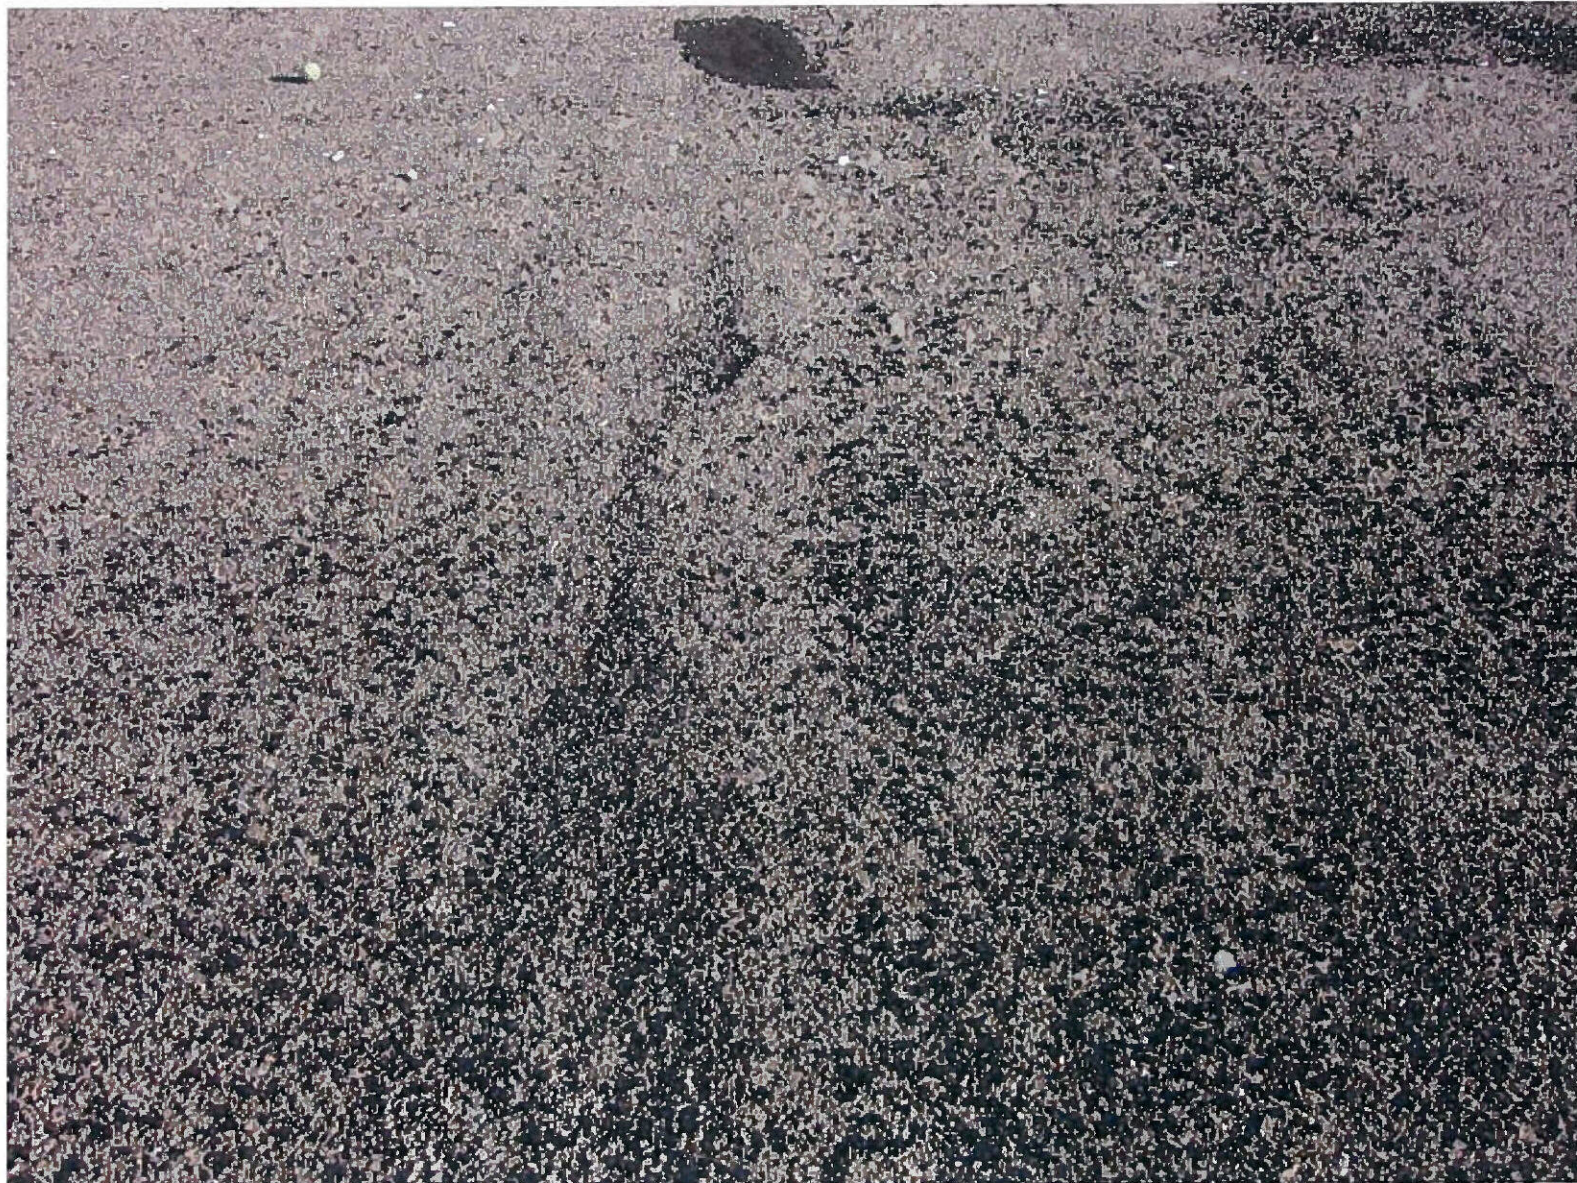
Failing roof structure

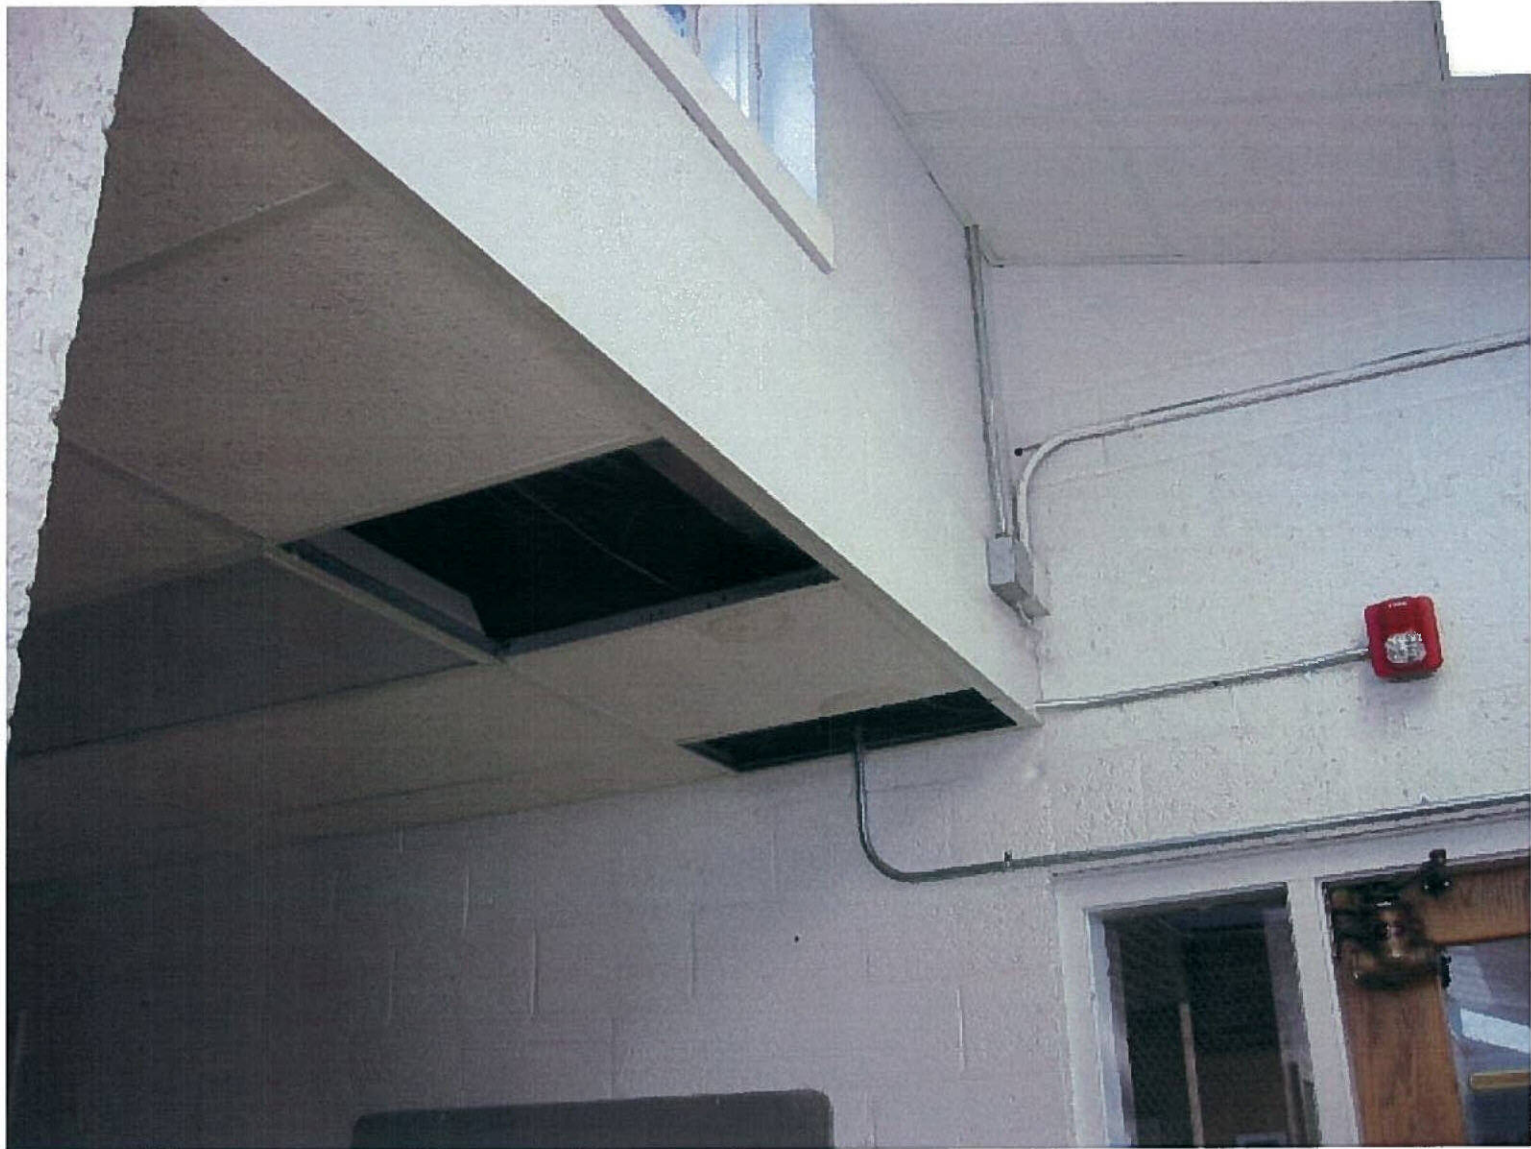
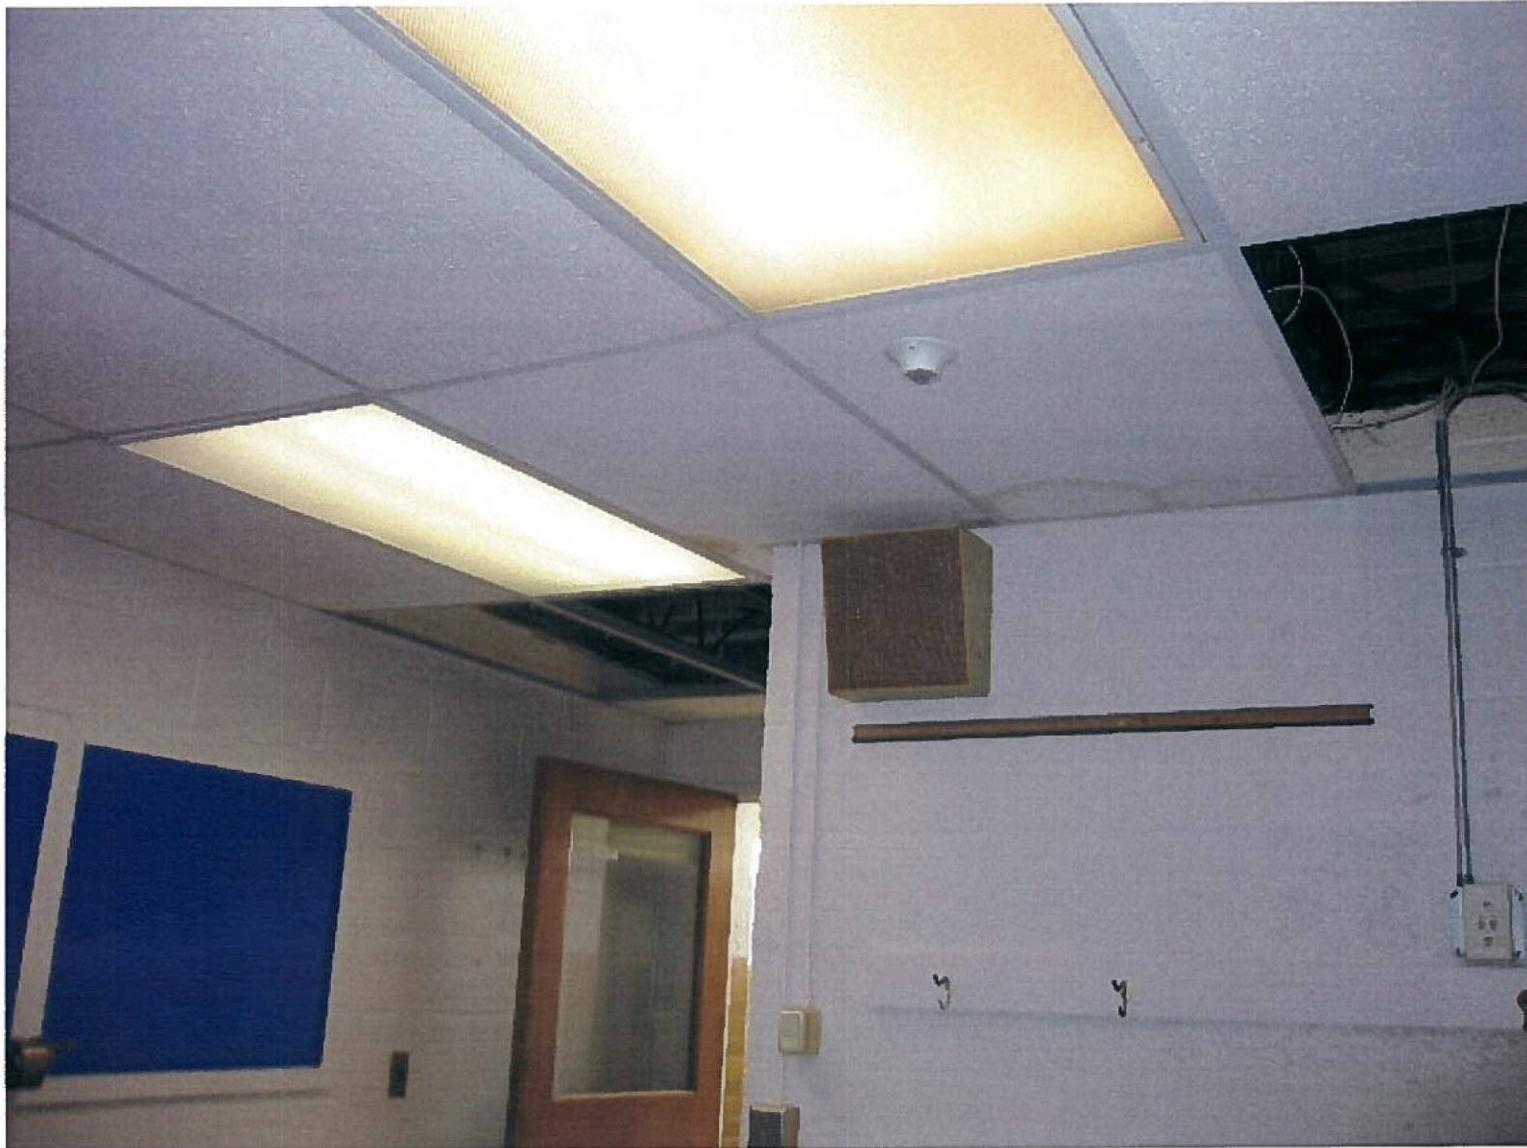
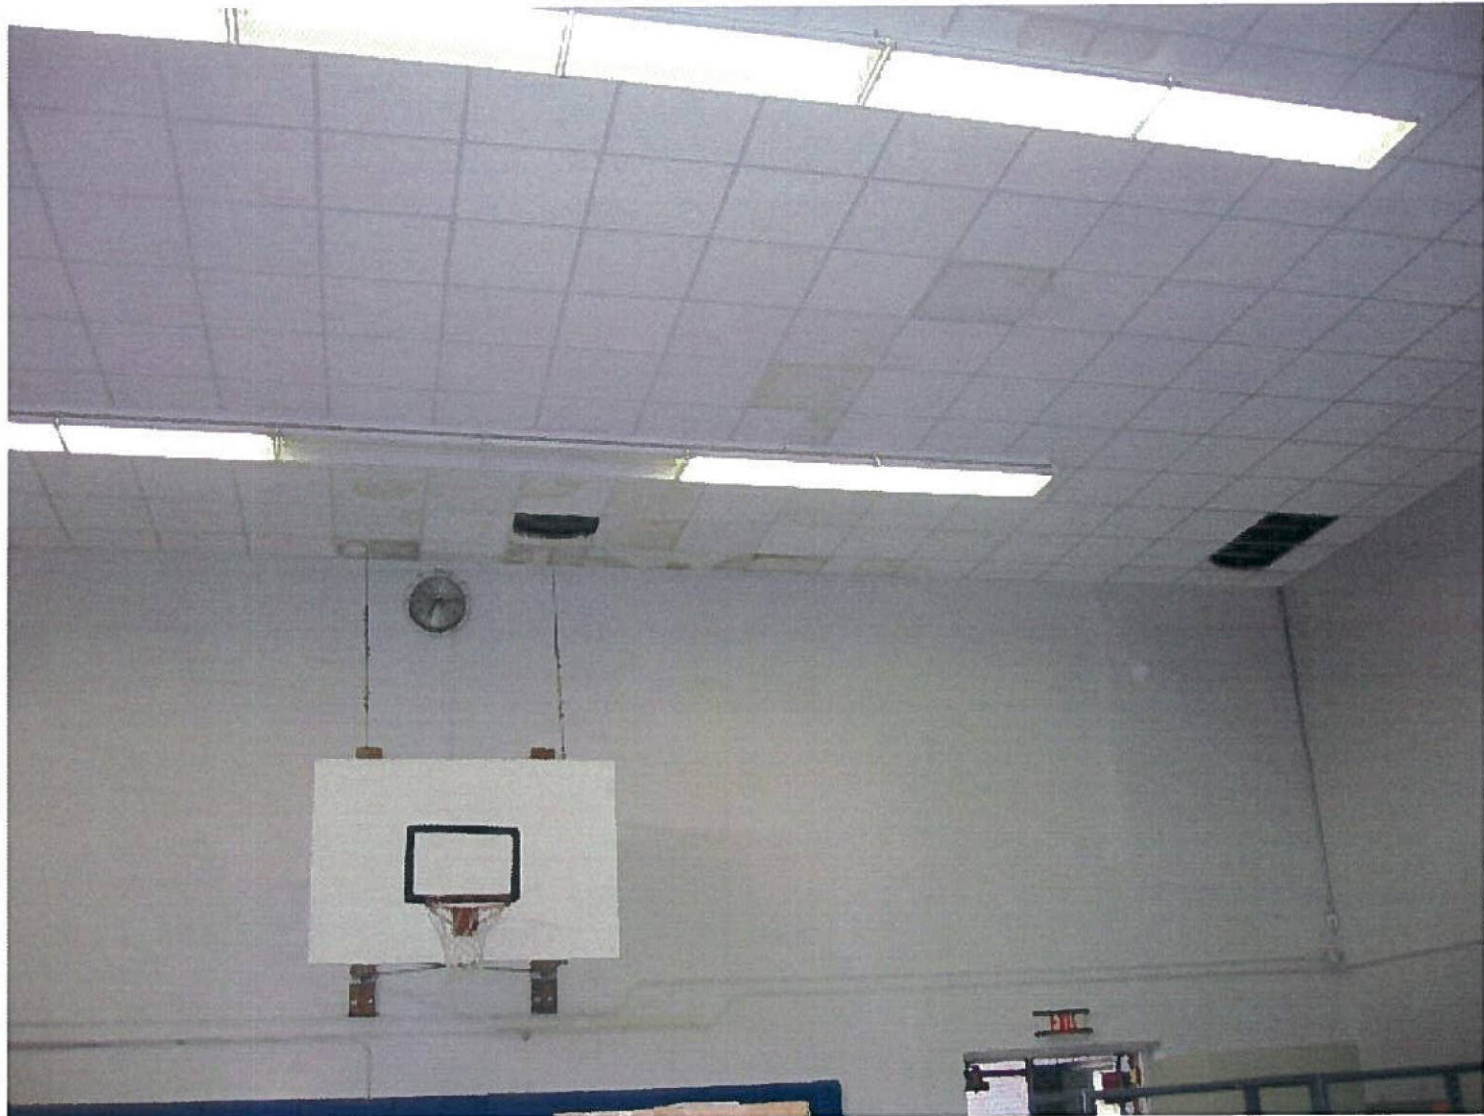
Although the walls and floors were maintained and are in good shape, the failing of the roof is causing the ceilings to deteriorate and thus they are in poor shape. (See photos on pages 20 - 24 of attached briefing.) Many ceiling tiles are missing or stained from the many roof leaks.

Failing roof structure – causes failure inside

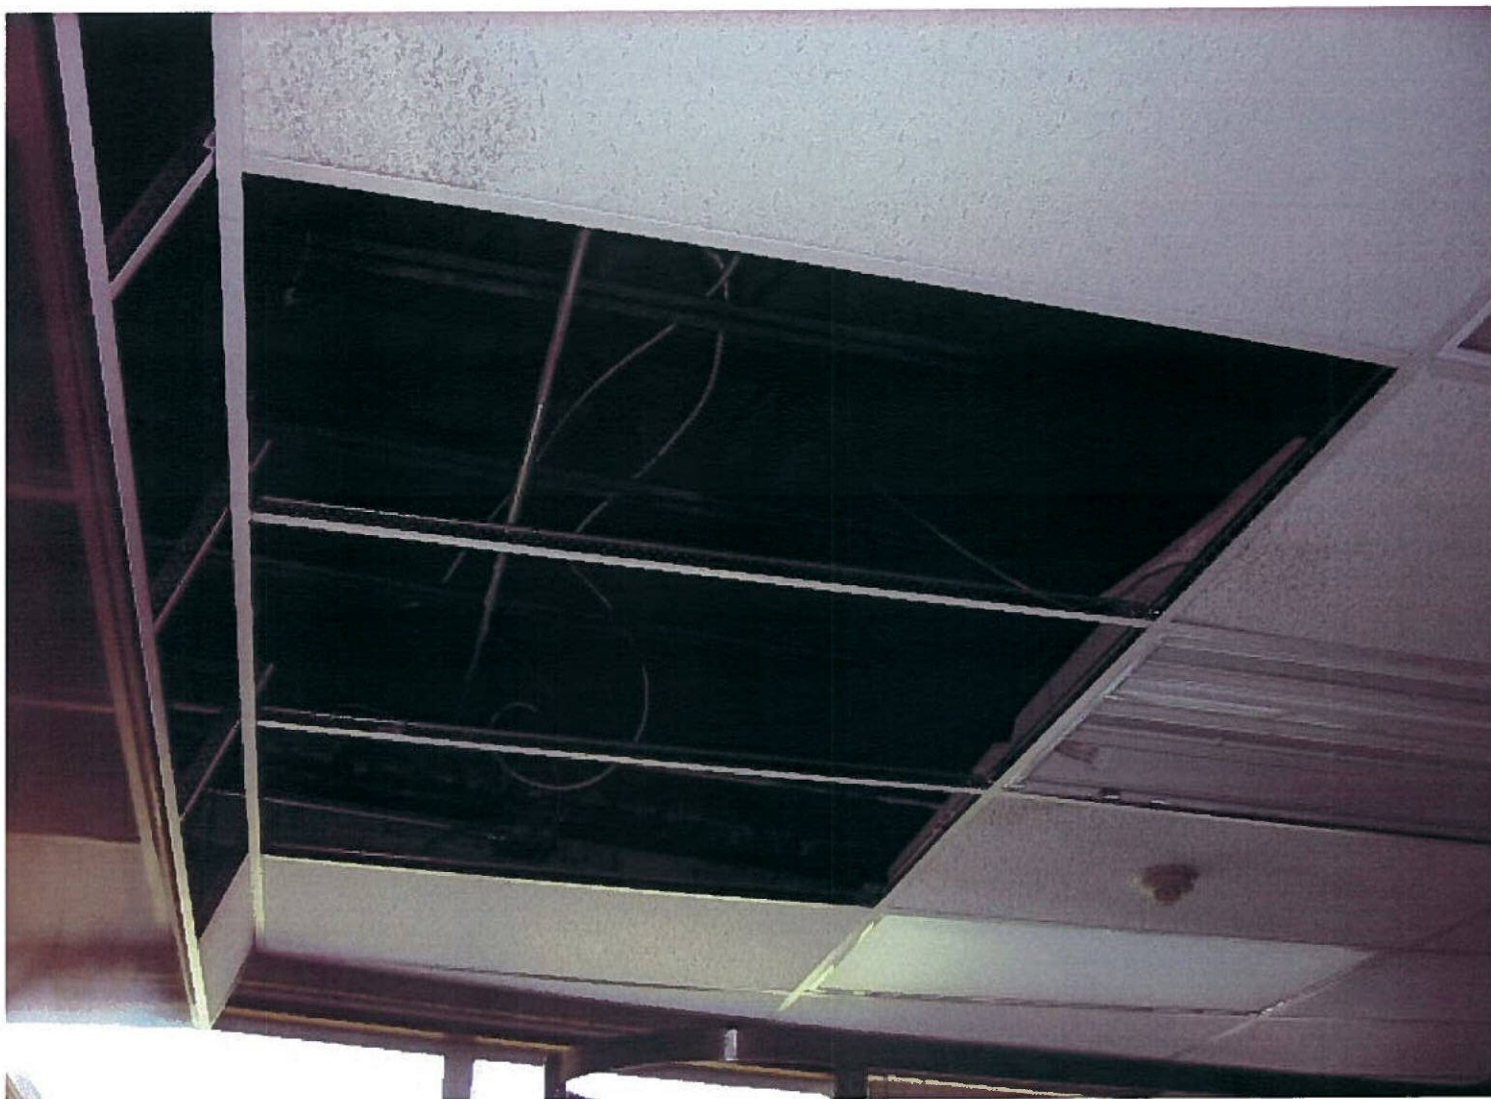
Roof leak in the Kitchen on May 27, 2010

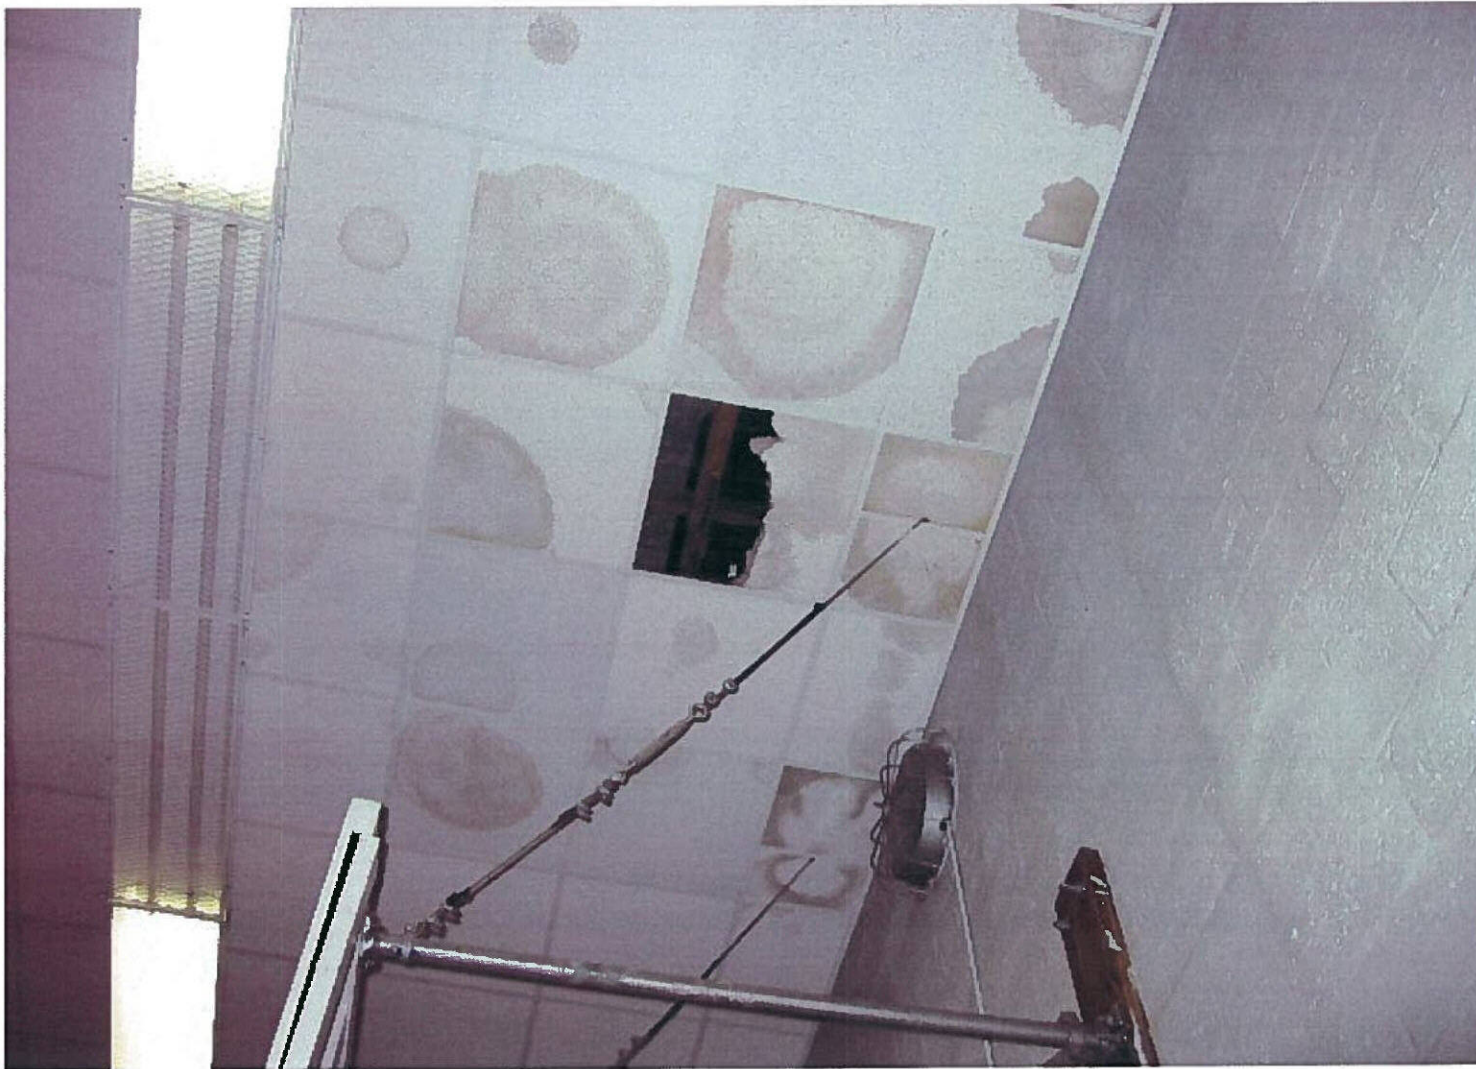
Roof leaks in the Gymnasium.
See previous photo to see where ceiling tile went.

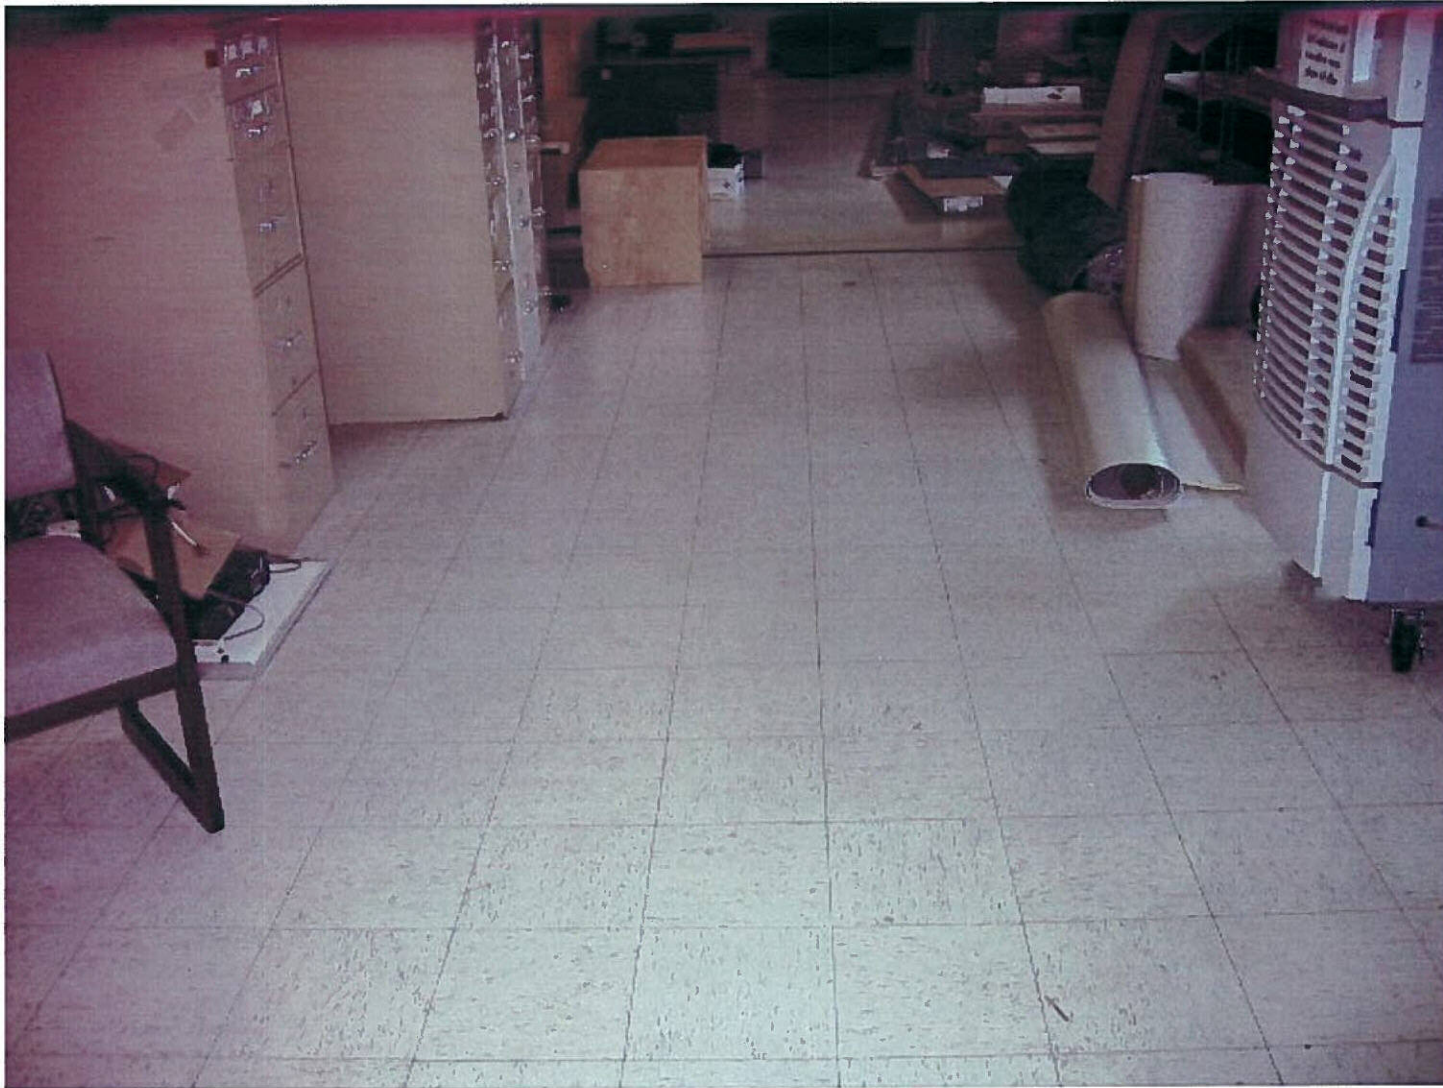
Gymnasium Floor – 12 inch square vinyl tile

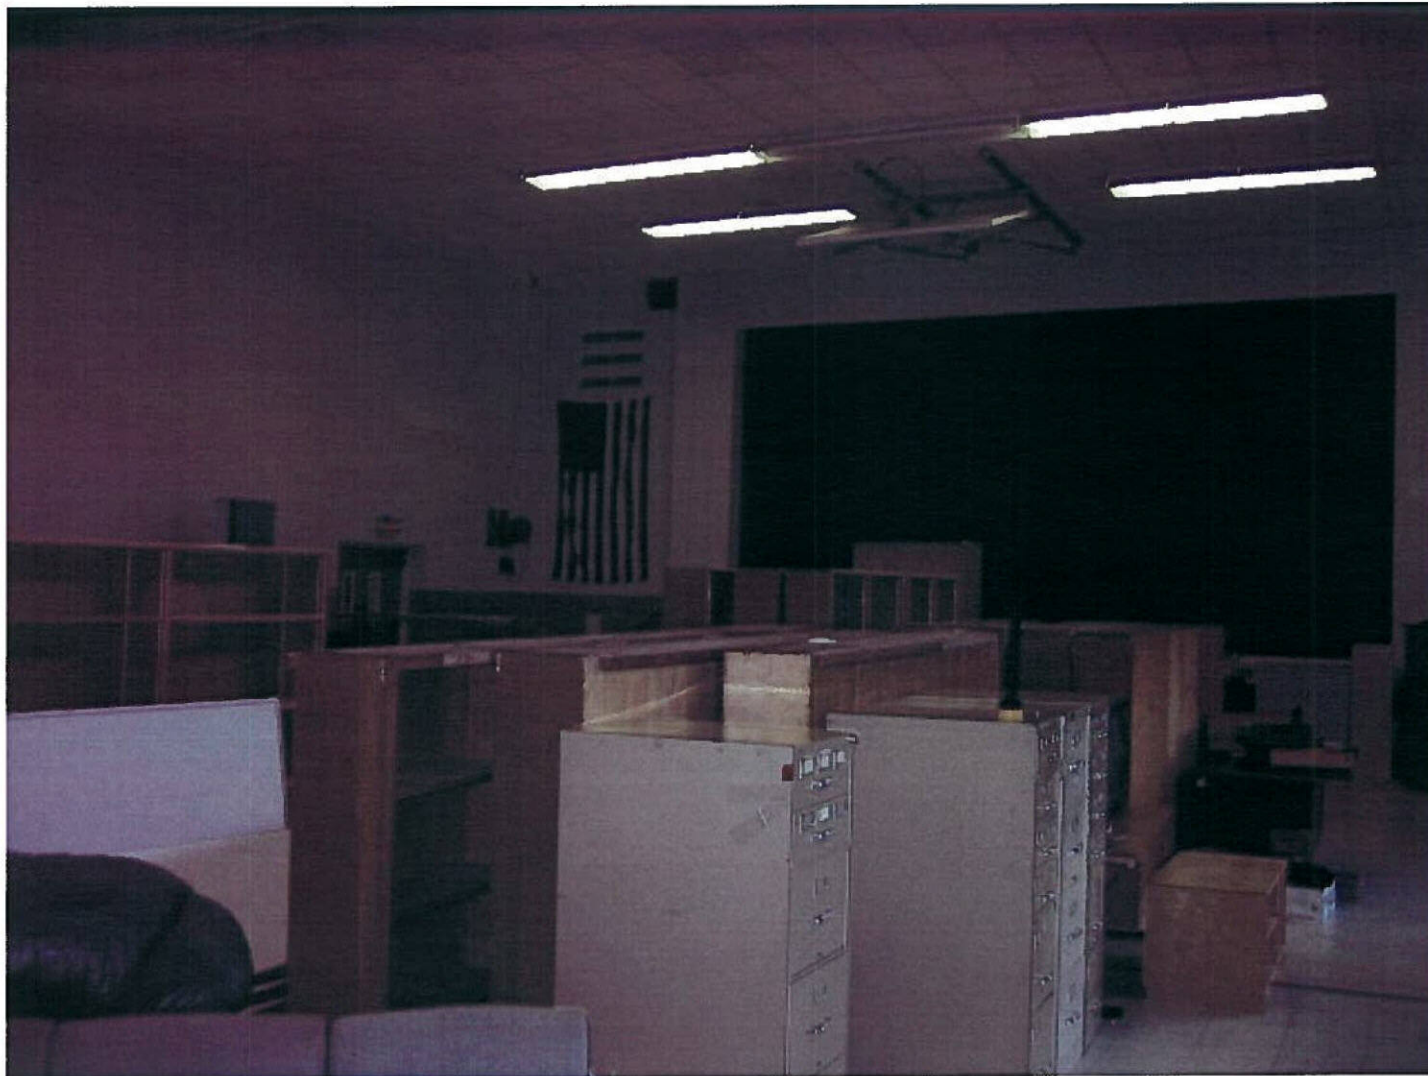
The gymnasium is not basketball regulation sized. It has vinyl floor tiles. It has very little room between sidelines and walls making it less safe for playing sports in the gymnasium. (See photos on pages 25 - 27 of attached briefing.)

Gymnasium is small. The basketball court is not regulation size. Old backboards, no area outside the lines and a stage on one end.

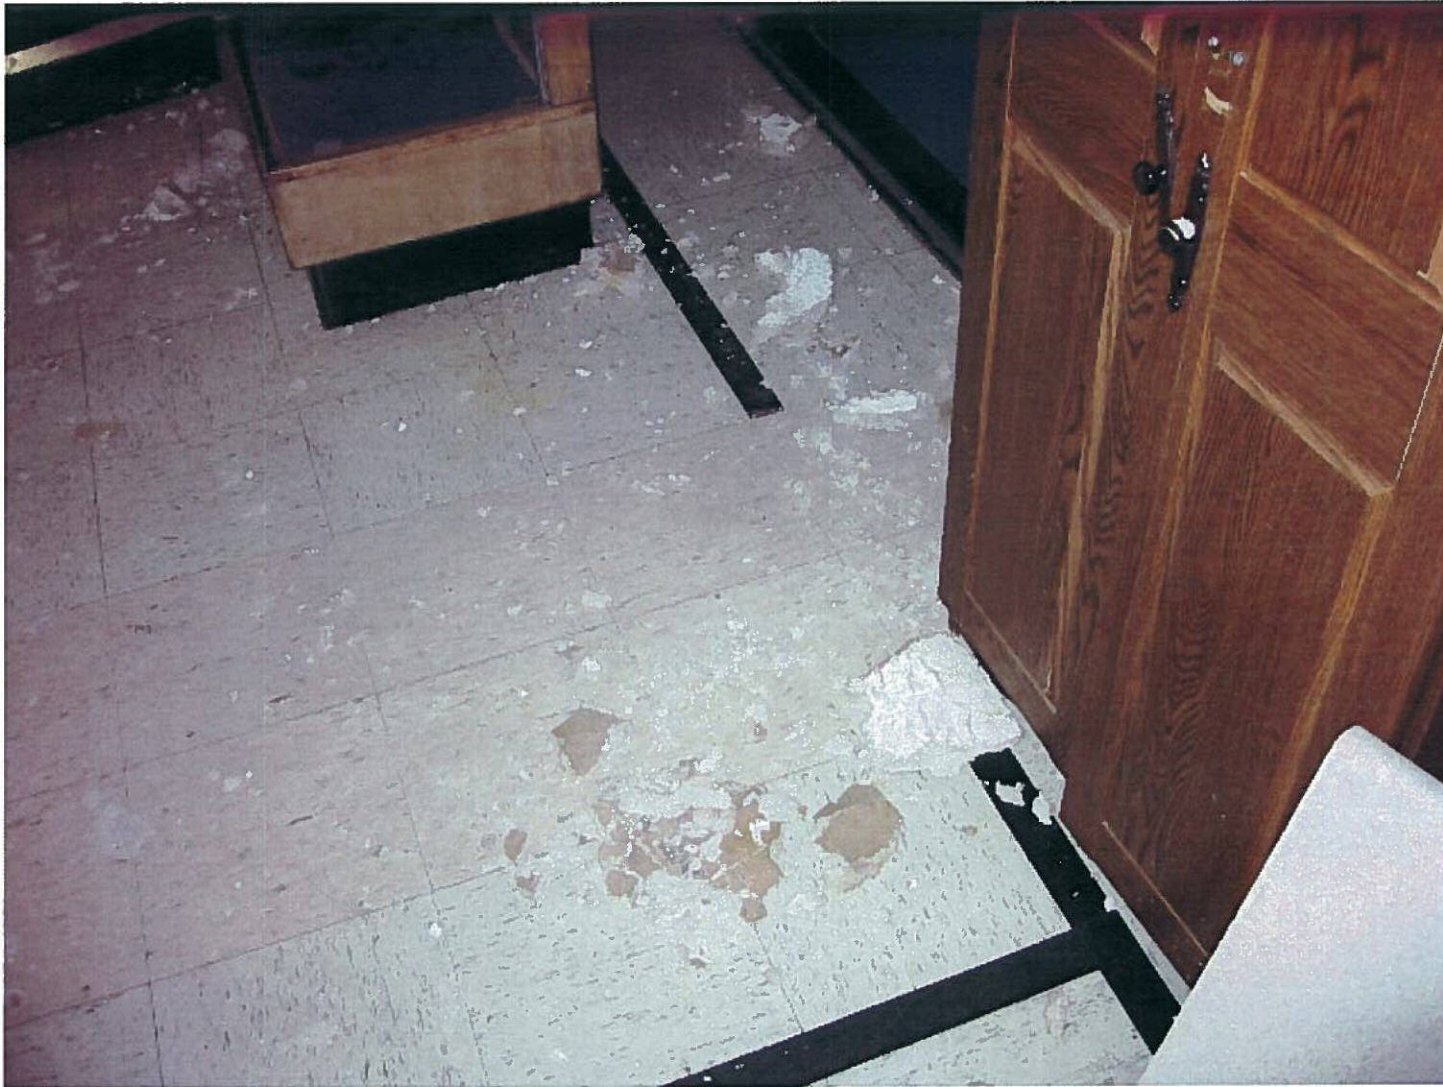
Gymnasium no area outside the lines between wall (approximately 18 inches)
This photo also shows the ceiling tile that fell to the floor due to roof leak.
